Machinery Messages

Protection against thrust bearing failure in a steam turbine

by **Charlie Jackson**
Turbomachinery Consultant

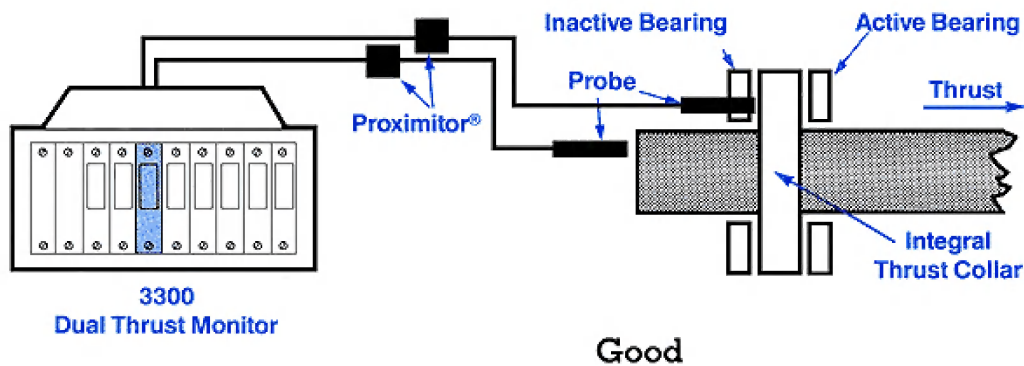
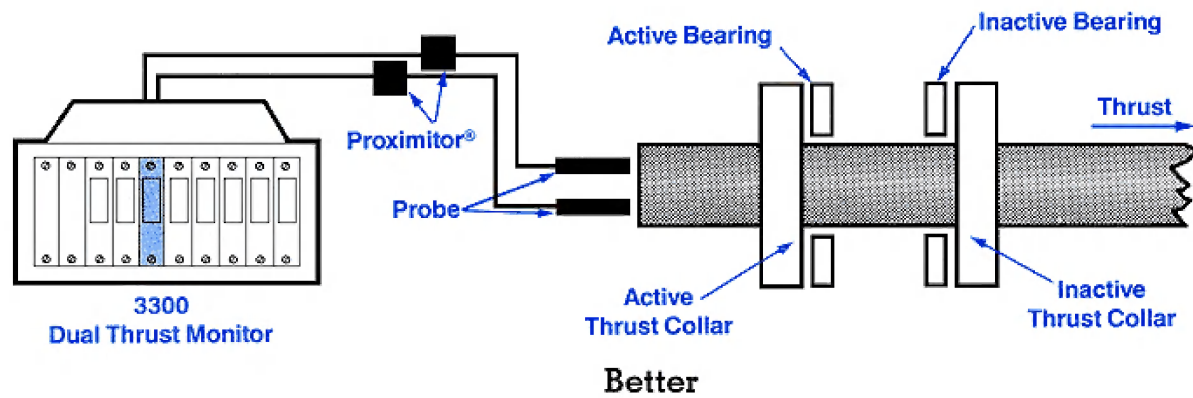
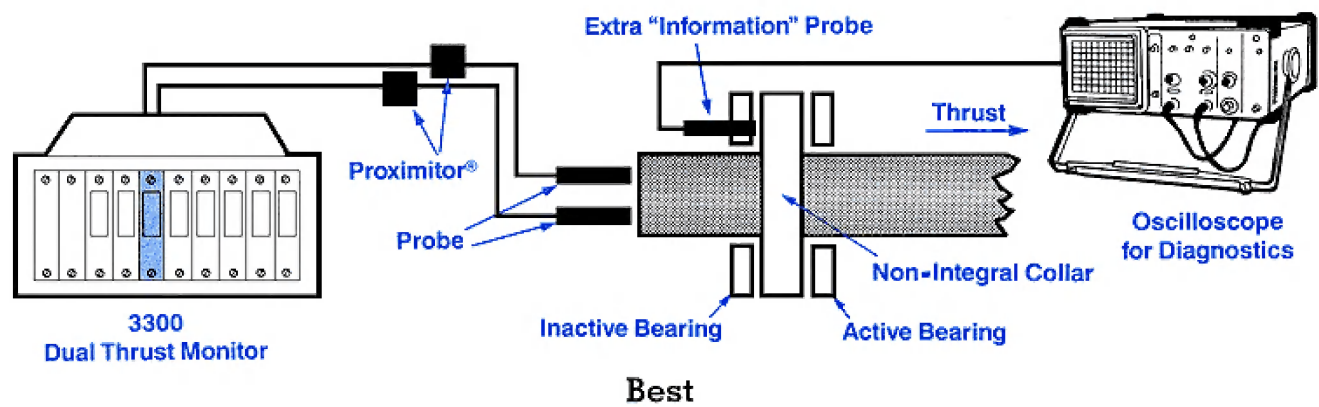
Figure 1
Thrust (Axial) probe arrangements

The best protection is an instrumentation system which is dedicated towards axial deflection detection, with dual-voting eddy current proximity sensors mounted in the turbine's steam inlet section as is shown in Figure 1. Generally, sensors are mounted in the steam end pedestal end plate. These two displacement probes, calibrated to the dc gap voltage, indicate the distance from the sensor tips to the end of the turbine shaft. The end of the turbine shaft must be in close proximity to the

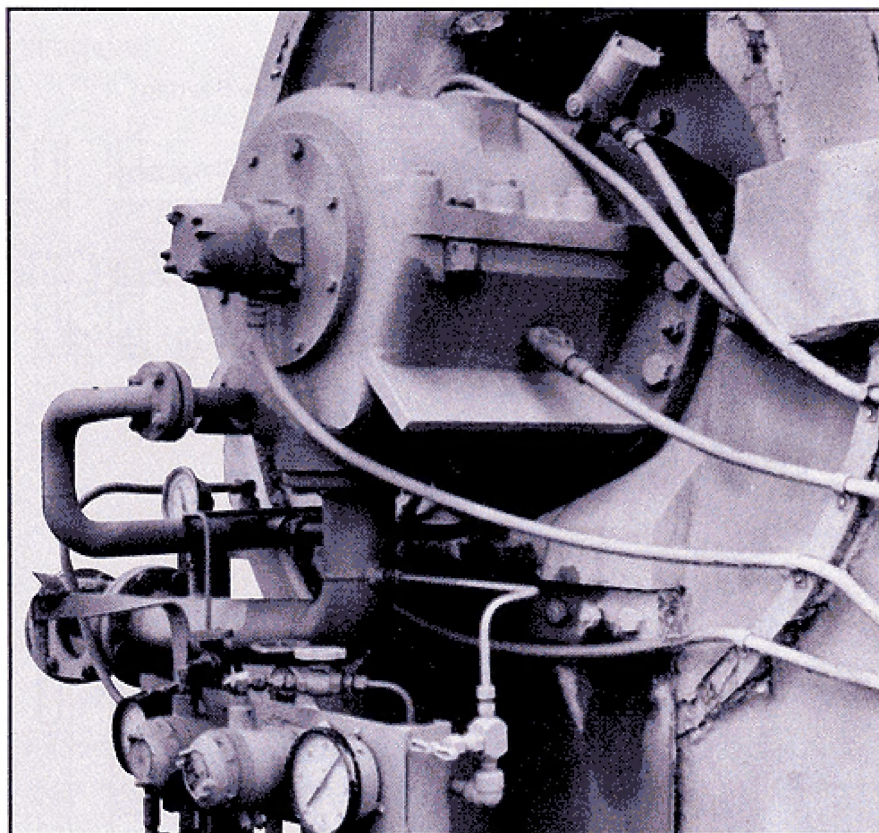
Figure 2
Dual thrust proximity probe machine protection assembly on a centrifugal compressor's discharge end bearing assembly.

Figure 2 shows a dual thrust protection assembly on a centrifugal compressor's discharge end bearing assembly. The radial vibration probes can be seen mounted in the standard API 670 XY configuration. The compressor incorporates a balancing piston

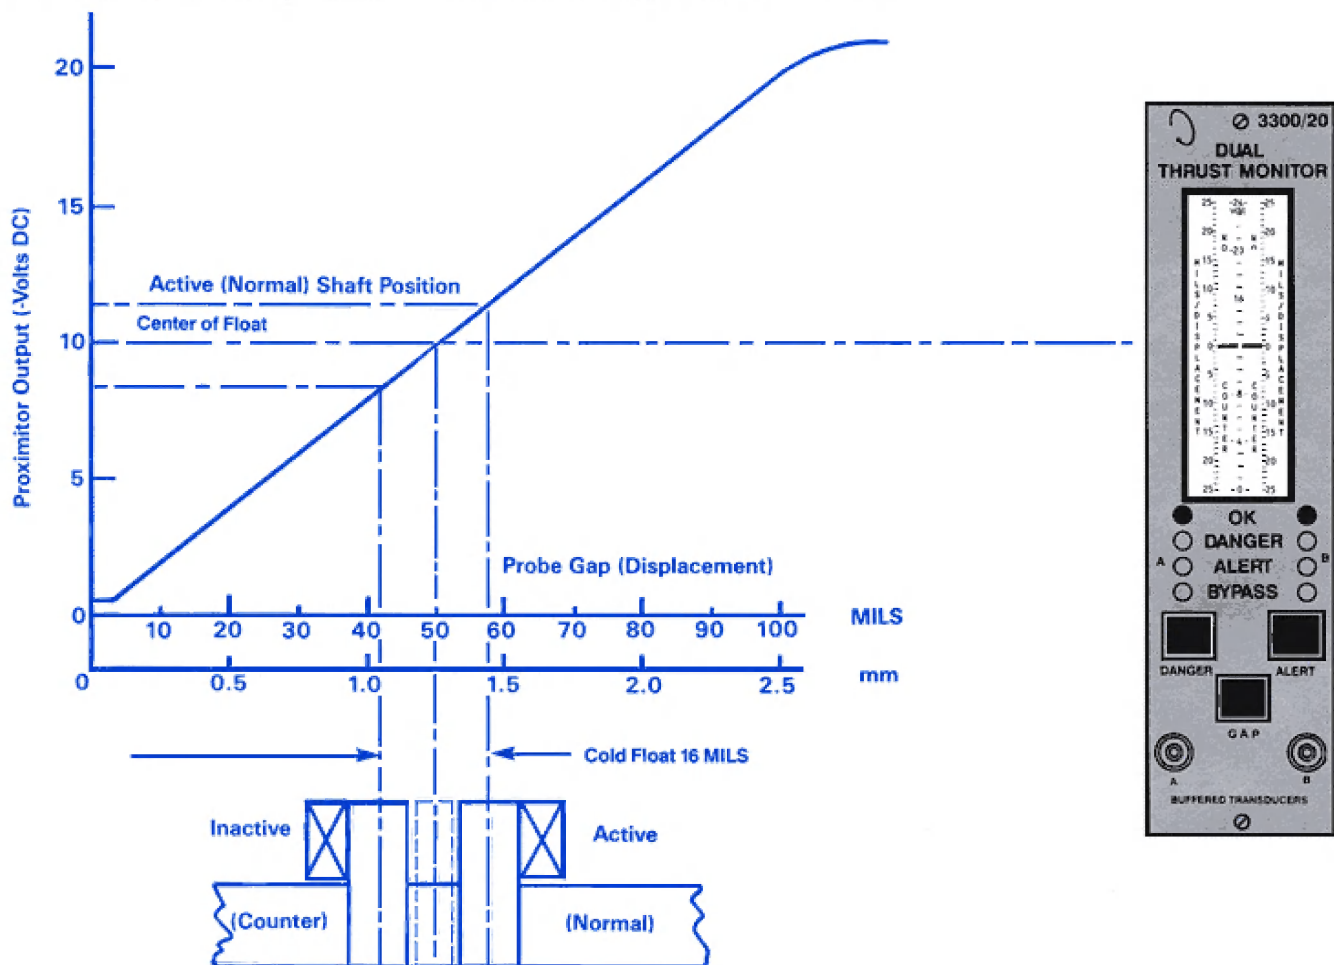
Figure 4

At 25 mils (636 μm), these machines will shut down automatically. The "cold float" on the turbines is 16 mils (406 μm). The cold float on the compressors is 17 mils (432 μm), i.e., active to inactive "bump" check. The cold float zone (Figure 4) is measured when the machine is at rest and cold (ambient

Center zero equals thrust collar in center of cold float zone as is shown on 3300/20 front panel display.
